USARTL-TR-78-13

REVIEW OF ENGINE/AIRFRAME/DRIVE TRAIN DYNAMIC
INTERFACE DEVELOPMENT PROBLEMS

W. J. Twomey, E. H. Ham
Sikorsky Aircraft
Division of United Technologies Corporation
Stratford, Conn. 06602

June 1978

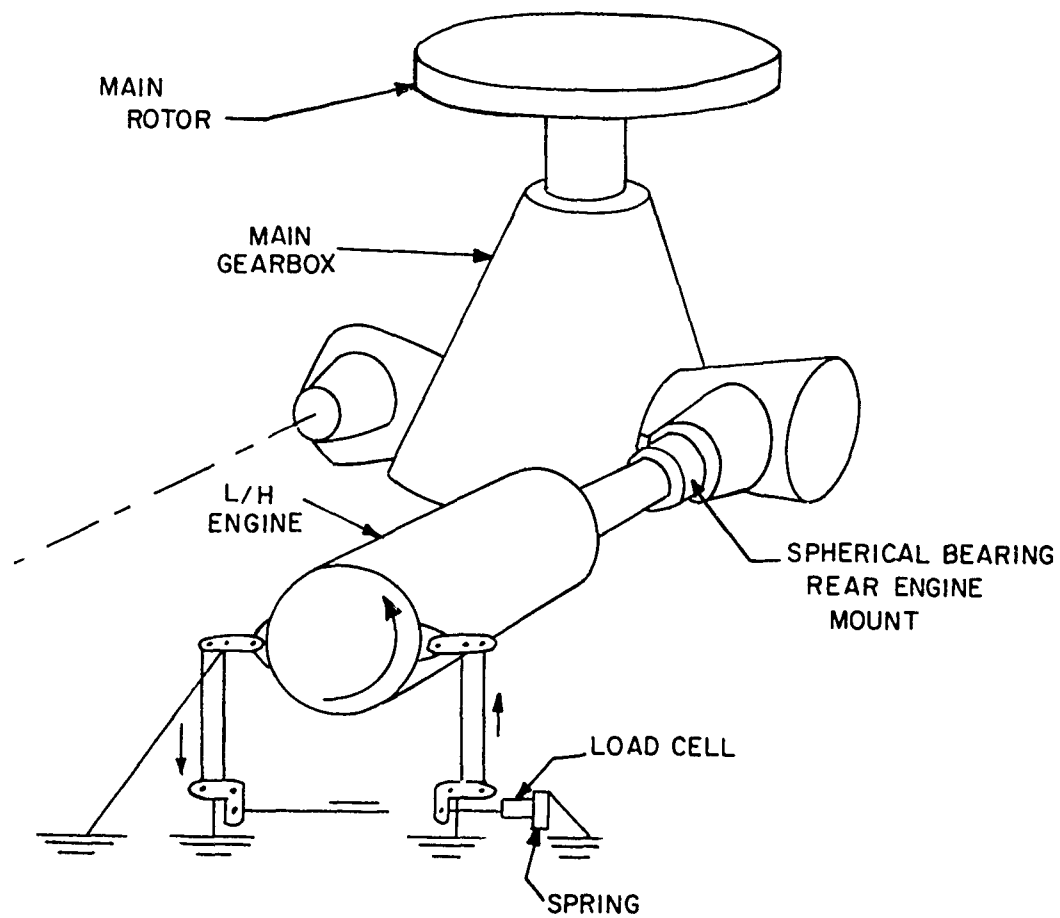
First indication of the problem was the observance of large (± 1200 SHP) fluctuations in the engine torquemeter. It was determined that these fluctuations were not actual engine power fluctuations but were caused by torsional vibration of the engine case which was being sensed by the reaction-type torquemeter system in use at that time. Figure 11 is a schematic of the engine installation and torque measuring system.

Figure 11. Schematic of Reaction-Type Torquemeter System.

Subsequent tests conducted with the spring installed demonstrated that the engine case torsional vibration was reduced by a factor of more than 6:1.

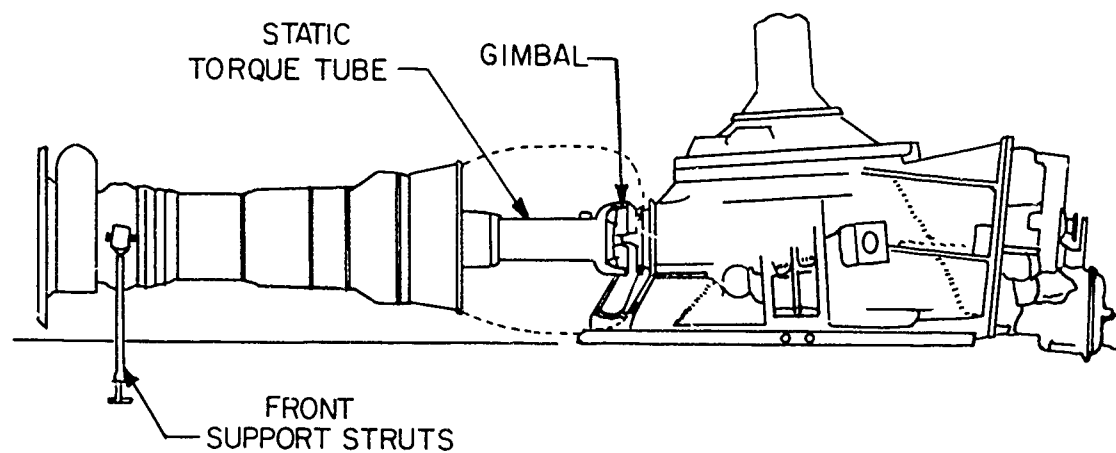
The first indication of this problem in the S-61L was the measurement of engine vibration levels which were above the maximum allowable, according to the engine environment specifications. The problem occurred in 1963 during developmental testing of the S-61L, which was a commercial derivative of the SH-3A. It was known from earlier studies of the SH-3A that these vibratory levels were high enough to cause a high stress problem in the power turbine bearing housing structure.

Figure 12. S-61 Engine Installation.

The solution was to increase the interface flexibility between the front frame of the engine and the airframe. Figure 12 shows the S-61L engine installation. The "hard" front engine support struts were switched to "soft" elastomeric isolation mounts. This lowered the resonant frequency of the critical first bending mode from 23 Hz to 10 Hz (Figure 13).

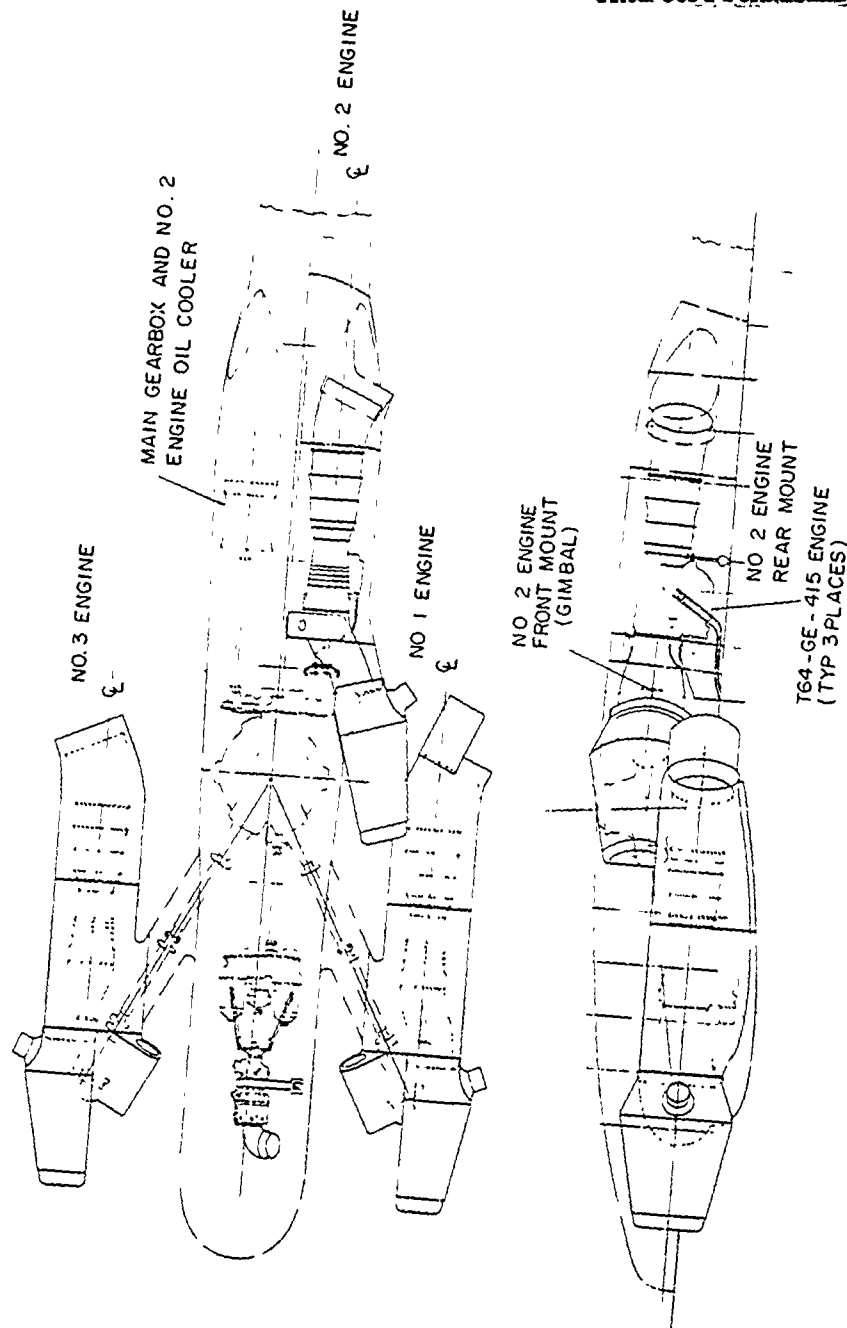
During development testing of the CH-53E propulsion system on the PSTB (propulsion system test bed) the number 2 engine experienced a drive shaft disengagement from the gearbox that resulted in extensive damage to the engine and moderate secondary damage to the stand. This incident occurred in April 1971.

Investigation revealed that the engine was longitudinally responsive to the main rotor 7P excitation frequency of 20.6 Hz. It is believed that the relative longitudinal motions were the cause of breakage of the spline shaft retaining clip which allowed disengagement of the spline and subsequent overspeed of the engine. Vibration levels were not measured in the longitudinal direction because there had not been an allowable limit established for this direction.

Figure 19. CH-53E Engine Arrangement.

The gimbal ring design was analyzed for feasible modifications for making a higher frequency installation. The concept of a lower frequency installation was discarded because it could cause additional wear on the spline due to larger relative motions between engine and gearbox. To expedite testing with a stiffer gimbal ring, a new one was manufactured of steel instead of aluminum as used in the original design. With this

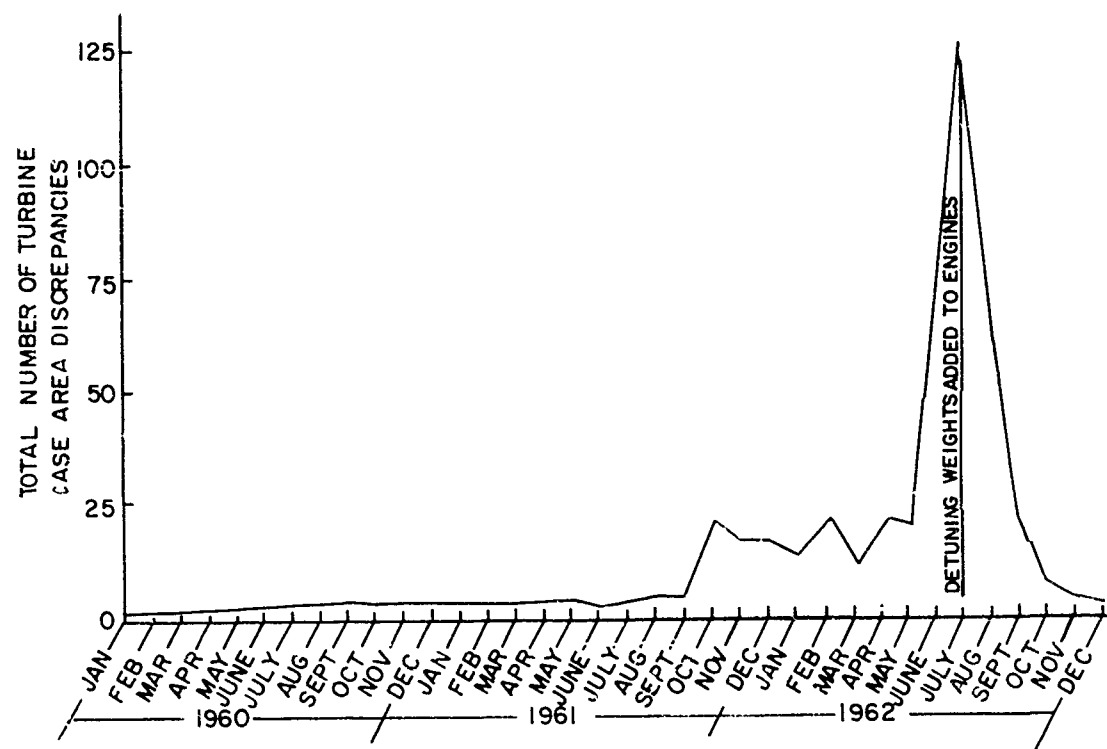
For nearly three years the development and production of the SH-3A aircraft proceeded without serious engine (T-58) installation problems. Then, rather suddenly (in June 1962), an almost exponential increase in the number of engine installation discrepancies was reported (Figure 23), the majority of which were fatigue cracks in the power turbine bearing housing flange.

Figure 23. History of Power Turbine Case Area Discrepancies.

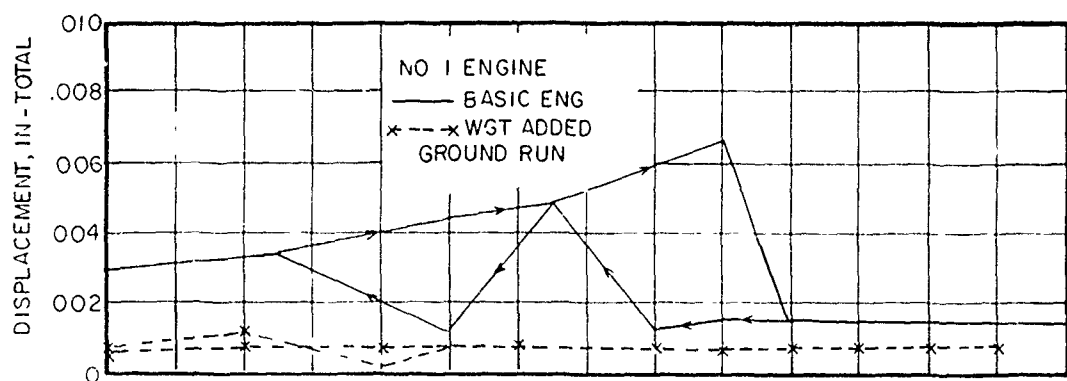
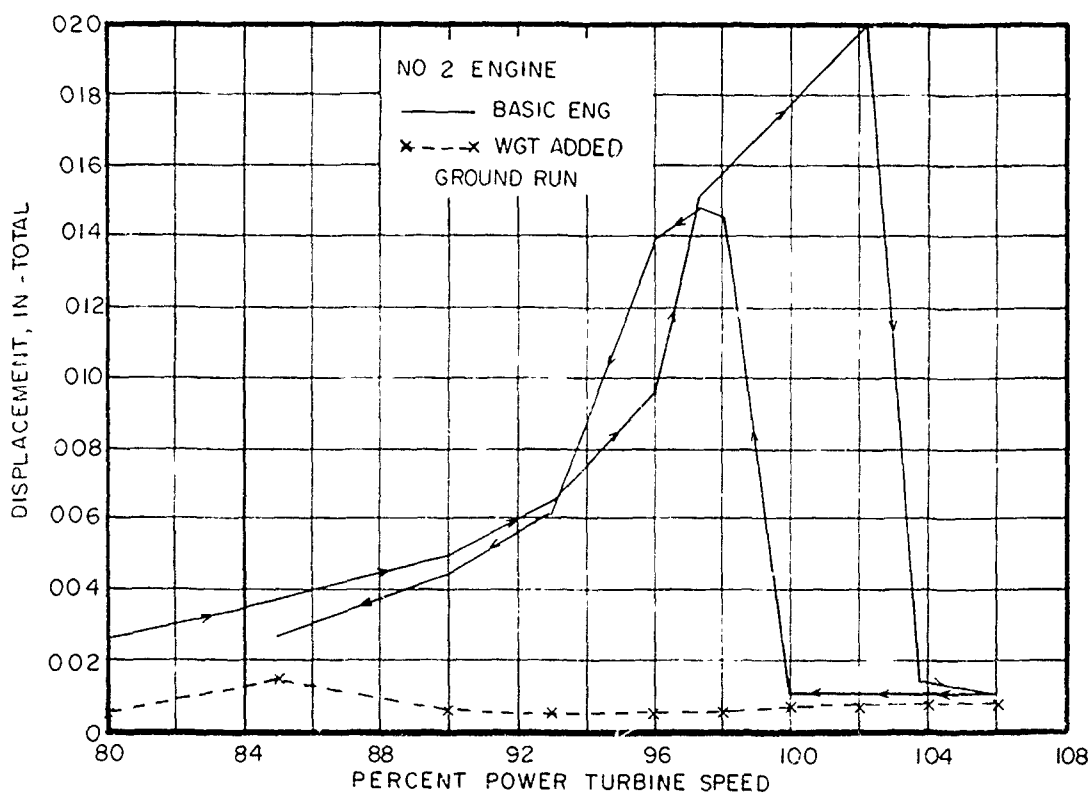
Figure 29. Engine Vibration - Effect of Adding 12½-Pound Weight to Torque Tube.

As shown in Figure 29, the weight lowered the resonance to 85% N_f which resulted in vibration levels within 3 mils at the bearing housing throughout the operating range.
